Replacing the rear crossmember bushings in a LM Corvair with the engine in place.

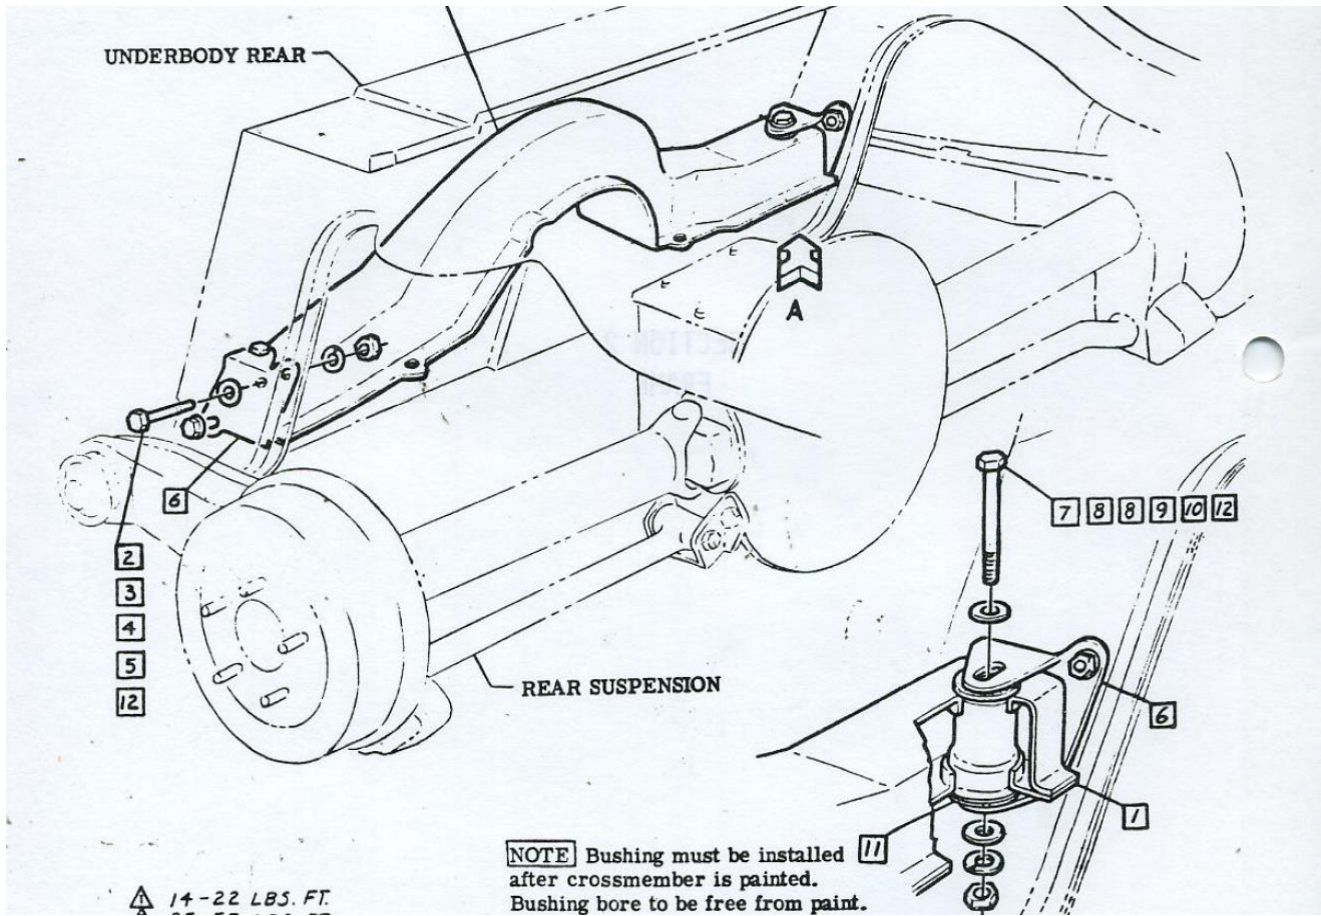
The above illustration from the assembly manual shows the crossmember captured by the brackets bolted to the chassis.

These brackets are made in such a way as to allow the crossmember to slide to the rear when the through bolt is removed.

After looking at the layout of the crossmember and seeing the way it is captured by a bracket at each end, I thought the bushing could be pulled in place.
